TECHNICAL ENFORCEMENT SUPPORT AT HAZARDOUS WASTE SITES

SUBJECT: Final Report for Work Assignment 336

RCRA Facility Assessment for

NGK Metals Corporation T336-R03-FR-DJXA-1

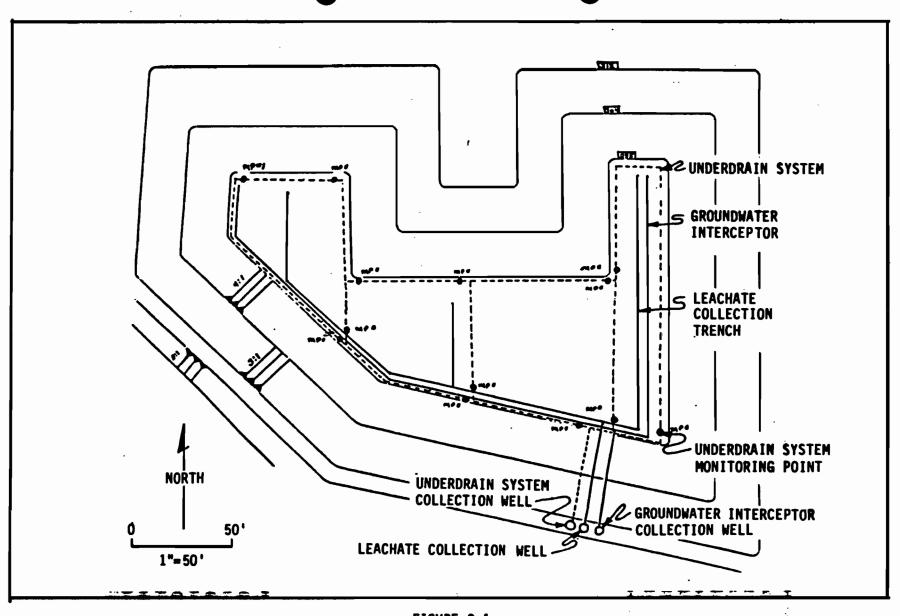
FIGURE 2-1
PLAN VIEW OF EXISTING LANDFILL SHOWING LOCATION OF UNDERDRAIN SYSTEM
LEACHATE COLLECTION SYSTEM, AND GROUND WATER INTERCEPTOR SYSTEM

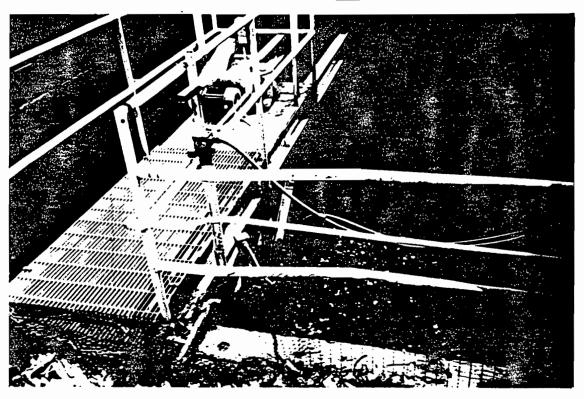
PHOTO <u>B-3</u>

DATE: 8-4-87 PLANT: NGK Metals Corp. DIRECTION FACING: West PICTURE DESCRIPTION: Waste Treatment Facility - neutralization tank

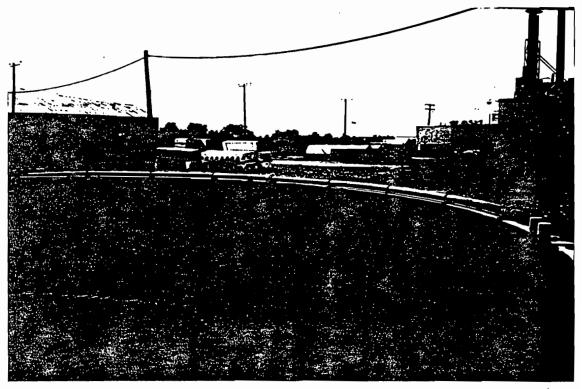
PHOTO <u>B-4</u>

DATE: 8-4-87 PLANT: NGK Metals Corp. DIRECTION FACING: Southwest PICTURE DESCRIPTION: Waste Treatment Facility - emergency storage tank

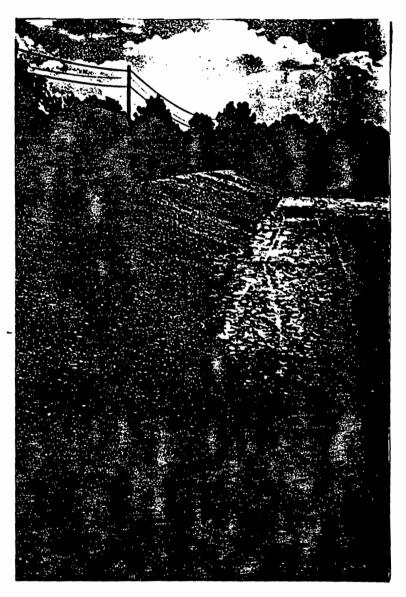
PHOTO <u>B-5</u>

DATE: 8-4-87 PLANT: NGK Metals Corp. DIRECTION FACING: South PICTURE DESCRIPTION: Existing Landfill - eastern berm

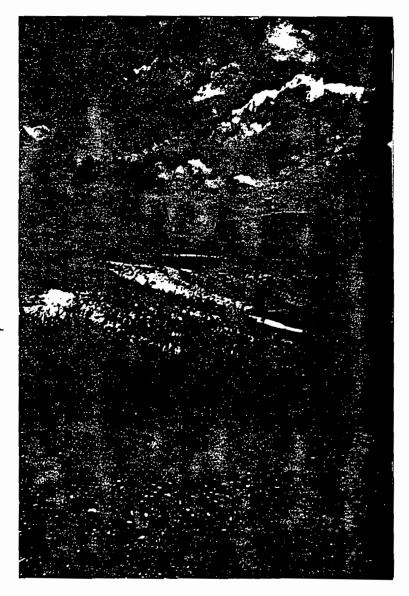
PHOTO <u>B-8</u>

DATE: 8-4-87 PLANT: NGK Metals Corp. DIRECTION FACING: East PICTURE DESCRIPTION: Existing Landfill - northern berm

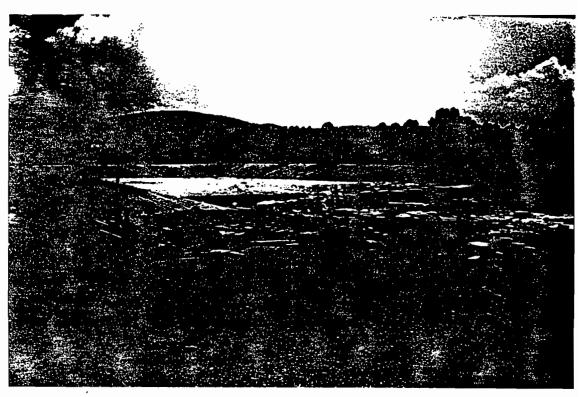
PHOTO <u>B-9</u>

DATE: 8-4-87 PLANT: NGK Metals Corp. DIRECTION FACING: Southeast PICTURE DESCRIPTION: Existing Landfill - from road entrance

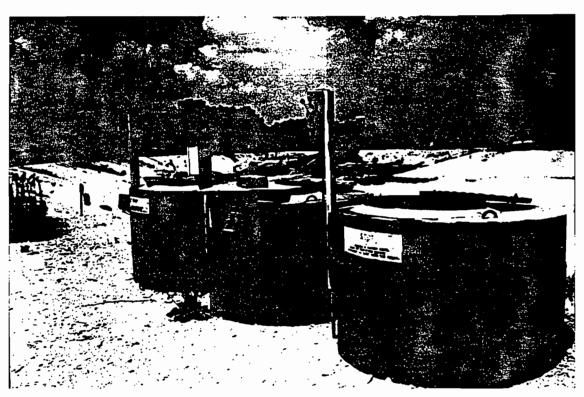
PHOTO <u>B-10</u>

DATE: 8-4-87 PLANT: NGK Metals Corp. DIRECTION FACING: Northwest PICTURE DESCRIPTION: Existing Landfill - collection tanks

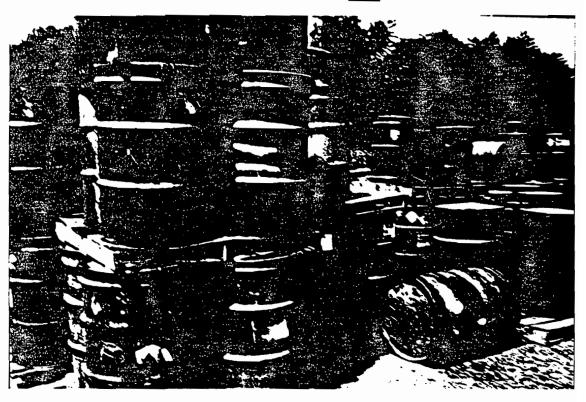
PHOTO <u>B-12</u>

DATE: 8-4-87 PLANT: NGK Metals Corp. DIRECTION FACING: Southwest PICTURE DESCRIPTION: Drum Storage Area - northeast of landfill

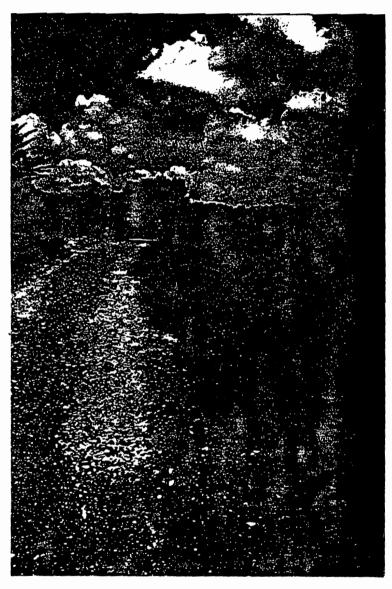
PHOTO <u>B-13</u>

DATE: 8-4-87 PLANT: NGK Metals Corp. DIRECTION FACING: North
PICTURE DESCRIPTION: West Berm of Existing Landfill and Drum Storage Area

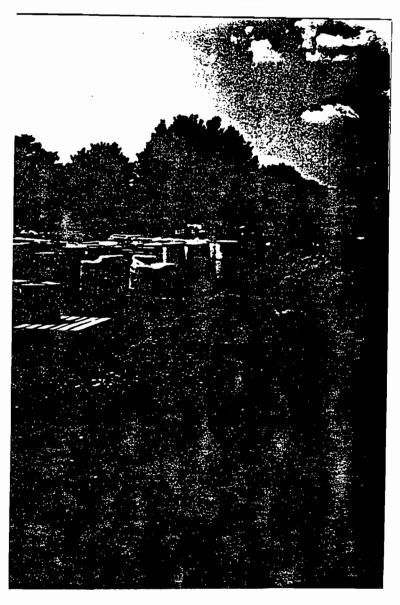
PHOTO <u>B-14</u>

Inspection of this SWMU during the VSI revealed that the ground surface was well vegetated. However, a relatively small area of what appeared to be red mud waste was exposed (Photos B-14 and B-24). Due to the exposed nature of the red mud waste, air and surface water are potential migration pathways. Additional analytical data to characterize the red mud and lime sludge waste are needed in order to determine if these disposal areas are capable of releasing hazardous constituents to air and surface water. These disposal areas are unlined. Therefore, subsurface gas, soil, and ground water are viable migration pathways. Additional analytical data are also needed to determine if releases have occurred to these media. Based on the aforementioned analyses conducted on the red mud waste, it is possible that these disposal areas are contributing to the contamination of ground water in the vicinity of the existing landfill (see Section 2.2.3). The relatively high concentration of fluoride present in samples taken from monitor wells in the vicinity of the landfill indicates that these disposal areas are a possible source.

DATE: 8-4-87 PLANT: NGK Metals Corp. DIRECTION FACING: Southwest PICTURE DESCRIPTION: Drum Storage Area - south of rolling mill

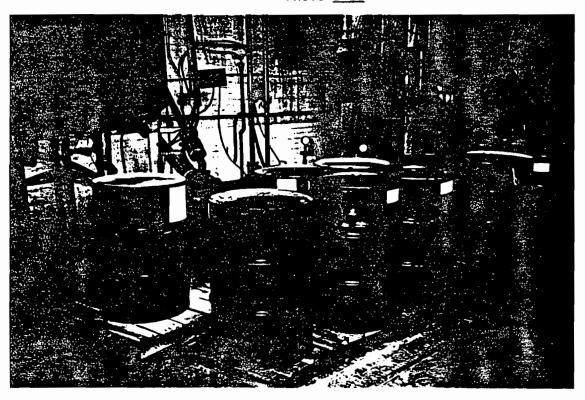
PHOTO <u>B-15</u>

DATE: 8-4-87 PLANT: NGK Metals Corp. DIRECTION FACING: Northwest PICTURE DESCRIPTION: TCA 1,1,1 Drum Storage Area

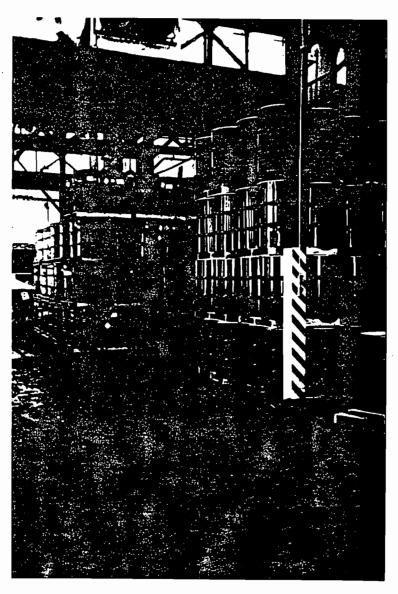
PHOTO <u>B-16</u>

DATE: 8-4-87 PLANT: NGK Metals Corp. DIRECTION FACING: North PICTURE DESCRIPTION: Drum Storage area - inside of building

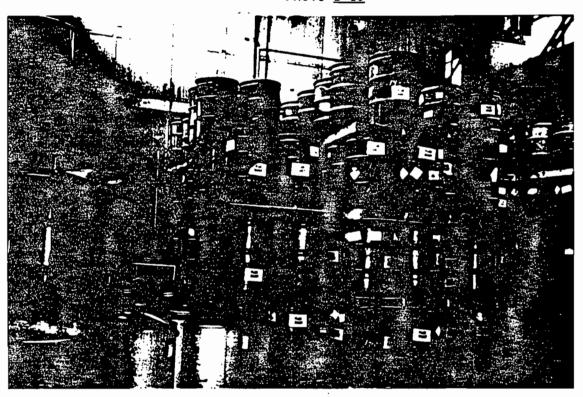
PHOTO <u>B-19</u>

DATE: 8-4-87 PLANT: NGK Metals Corp. DIRECTION FACING: Northeast PICTURE DESCRIPTION: Drum Storage Area - inside of building

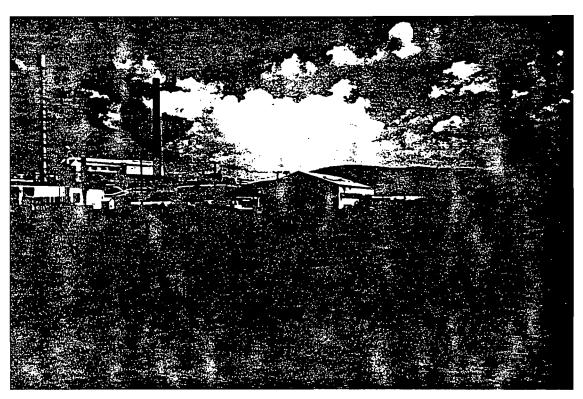
PHOTO <u>B-20</u>

DATE: 8-4-87 PLANT: NGK Metals Corp. DIRECTION FACING: Northeast PICTURE DESCRIPTION: Red Mud and Lime Sludge Disposal Areas

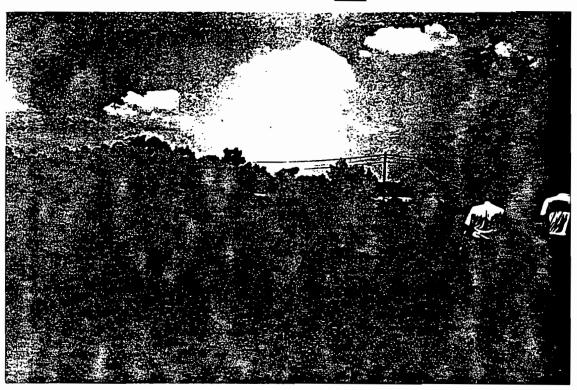
PHOTO **B-22**

DATE: 8-4-87 PLANT: NGK Metals Corp. DIRECTION FACING: Southwest PICTURE DESCRIPTION: Red Mud and Lime Sludge Disposal Areas
